| <p style="text-align: center;"><b>URGENT FIELD SAFETY NOTICE</b><br/> <b>MEDICAL DEVICE FIELD CORRECTION</b><br/> <b>Maquet/Datascope CARDIOSAVE Intra-Aortic Balloon Pump (IABP)</b></p> |

| AFFECTED PRODUCT | PART NUMBER | DISTRIBUTION DATE |
| Cardiosave Hybrid IABP | 0998-00-0800-XX & 0998-UC-0800-XX<br>(excluding 0998-00-0800-83, 0998-UC-0800-83 & 0998-00-0800-75) | March 06, 2012 through<br>April 26, 2018 |

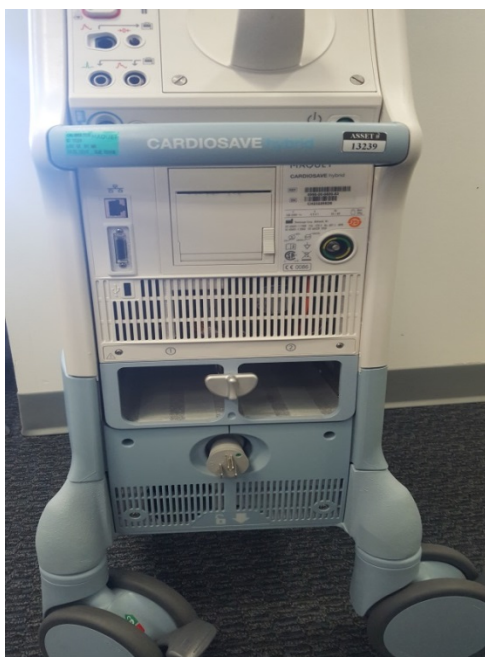
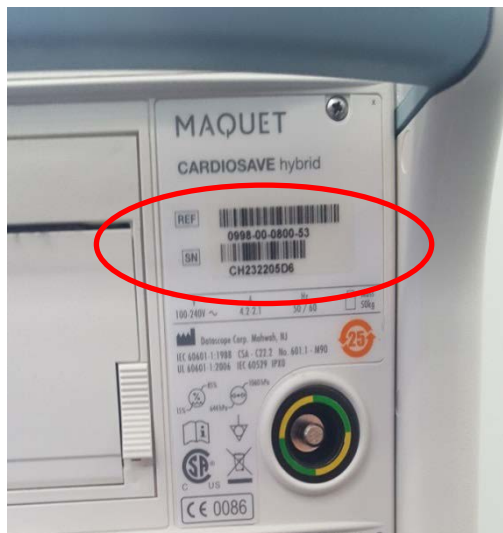
**Figure 1: CARDIOSAVE IABP – Location of Part Number (REF) and Serial Number (SN)**

CARDIOSAVE IABP units are serialized. The part number and serial number can be found on the front panel of the CARDIOSAVE IABP unit. Please refer to **Figure 1** on page 3 for a depiction of the CARDIOSAVE IABP and the location of the part and serial numbers.
